Home Probe, Inc

THERMAL IMAGING AND HOME INSPECTION

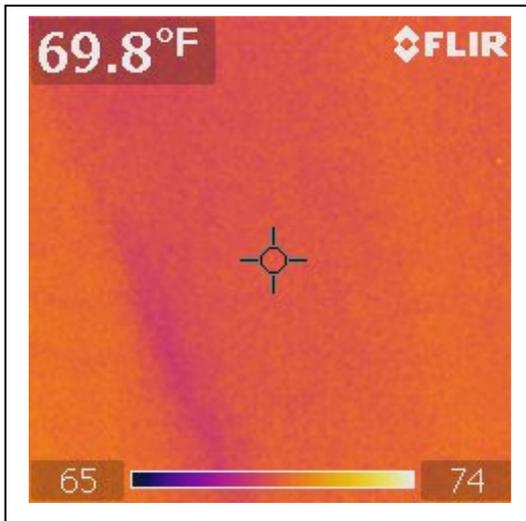
Review the photos below. The image on the left was taken with an infrared camera. The image on the right was taken, from the same area with a standard digital camera. There is a visible area of heat loss on the left side of the ceiling (helpful in an energy audit) but the water leak that is noticed in the normal image is not detected. This is because there has not been rain at this building for several days and there is no water present to cool this area and create temperature difference. It's not likely that the small area of heat loss would sway a purchaser one way or another in their buying decision. However, it is likely that the decision of buying a home that may need a new roof, in short order, could impact how one may proceed with the transaction.
